## Designing for Tornado Alley

# Debris Impact Testing of Coreslab Hollow Planks

Clemson University conducted debris impact testing of Coreslab Hollow Planks (CHP) intended for use in tornado shelter roofs and elevated-floor systems. The testing was performed in general accordance with the 2020 ICC 500 ICC/NSSA Standard for the Design and Construction of Storm Shelters, using 15-pound 2x4 lumber missiles and a target impact speed of 67 mph for horizontal surfaces associated with a 250-mph design wind speed. The test program evaluated 10-inch and 12-inch CHP sections, 8-foot and 16-foot spans, simple-span and three-side-support conditions, and systems with and without edge pours and topping slabs.

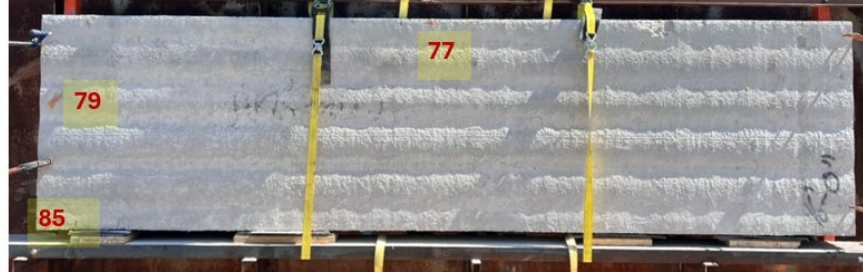
### Specimen 10-16-1

| Impact Location | Missile Speed (mph) | Missile Weight (lbs.) | Result |
|---|---|---|---|
| Corner, above solid | 85.3 | 14.93 | Corner cracks |

The cracked corner was easily removed by hand when the specimen was lifted from the test frame. It follows the same pattern as the specimens spanning 8 feet. The corner shot was ~25% faster than the ICC requirement. The missile speed was reduced for the next test, specimen 10-16-2.

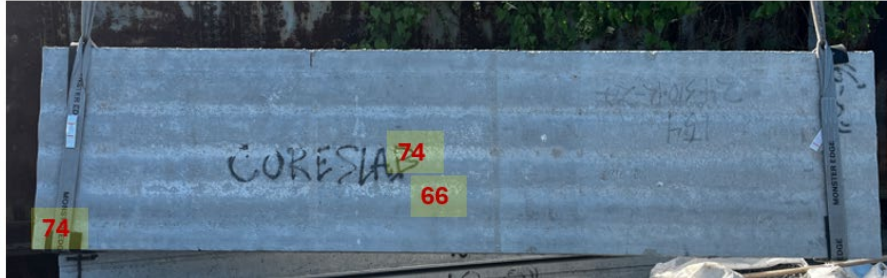
### Specimen 10-16-2

| Impact Location | Missile Speed (mph) | Missile Weight (lbs.) | Result |
|---|---|---|---|
| Corner, near hollow | 74 (backup) | 14.93 | Corner spall |

Pressure was reduced in the cannon so that the missile speeds would be closure to the ICC value of 67 mph. At the reduce speed, the corner shot still caused damage.

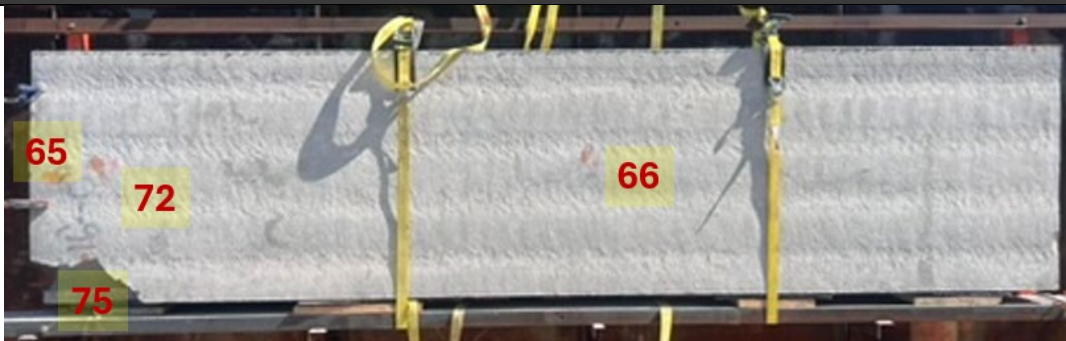
**Specimen 12-16-2**

| Impact Location | Missile Speed (mph) | Missile Weight (lbs.) | Result |
|---|---|---|---|
| Near corner, above hollow | 75.2 | 14.84 | Corner spall |

The lower left corner had one of the largest spalls in the test program. The missile's impact caused damage while traveling at ~10% above the ICC-required speed.

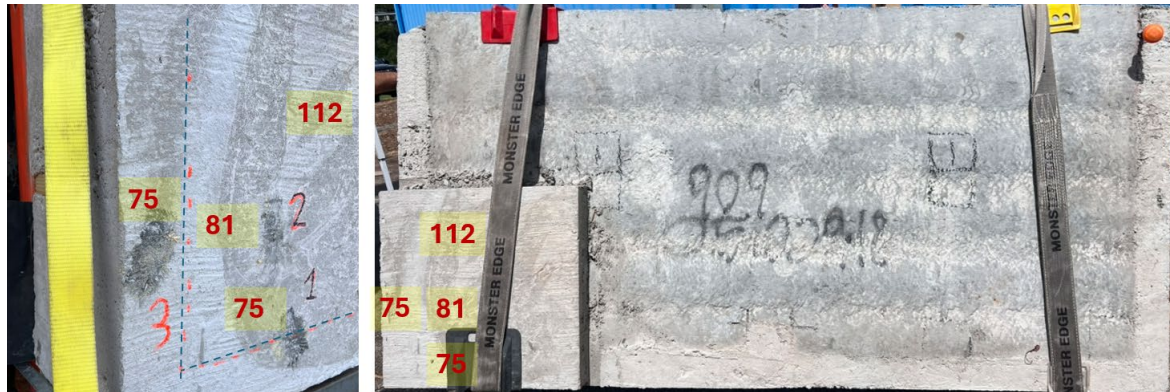
## Specimen 10-8-3 (phase 2)

Dashed lines in left image indicate the location of the edge pour/CHP interface.

The second impact (80.6 mph) occurred at the critical location from phase 1. For the final impact, the missile speed was increased to approximately double the ICC 500 speed. Even with the critical locations and increased speed, no cracking, spalling, topping delamination, or other damage was observed.

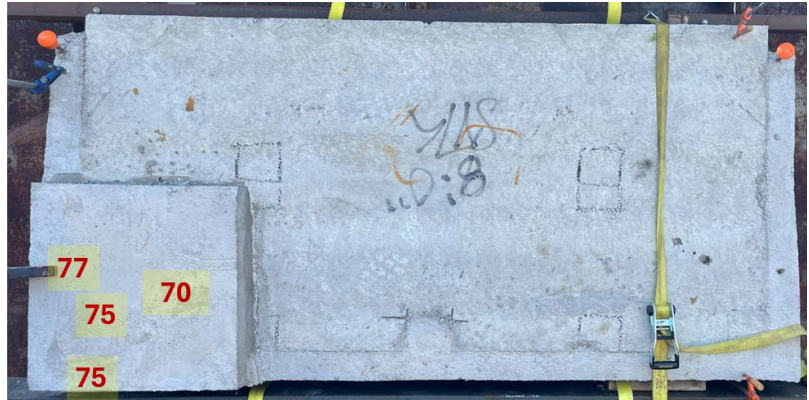
## Specimen 12-8-3 (phase 2)

Dashed lines in left image indicate the location of the edge pour/CHP interface.

The third impact matched the critical corner location observed in Phase 1. Even with impact at the critical location, no cracking, spalling, topping delamination, or other damage was observed.
